Monitoring Data RecordProject Title: R-2719A Crescent Road COE Action ID: 200802460WQC Number: 003763Stream Name: UT to Falling CreekCity, County and other Location Information: UT to Falling Creek is located on US 70 just west of the C.F. Harvey Parkway interchange in Kinston, Lenoir Co.Date Construction Completed: 3/3/11Monitoring Year: ( 4 ) of 5Ecoregion: Southeastern Floodplains and Low Terraces 8 digit HUC unit 03020202USGS Quad Name and Coordinates: 35.261881, -77.683669**Rosgen Classification:** E5Length of Project: 2,393' Urban or Rural: Rural Watershed Size: 0.5 sq. milesMonitoring DATA collected by: M. Green, J. Young, J. Elliott, and P. AllenDate: 6/10/15

# UT to Falling Creek

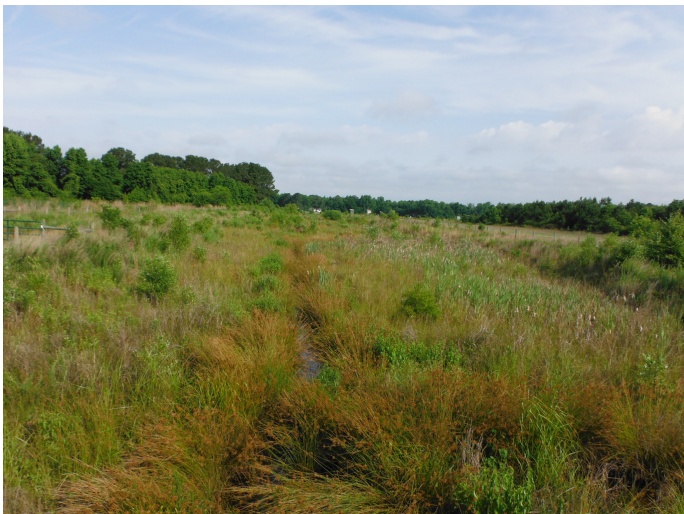
Overview photo looking upstream from US 70

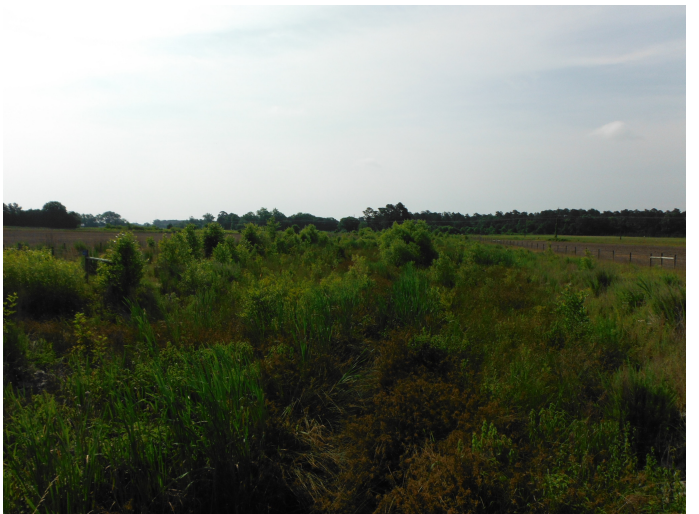
Overview photo looking downstream from US 70
